# **Report of Structural Inspection and Condition Assessment of Trimming Room - Areas 2 & 3 and Press Room - Area 12\* at the Former Bossert Manufacturing Facility**

Utica, New York

**EARTH TECH, INC.**

*Project No. 24708.01*

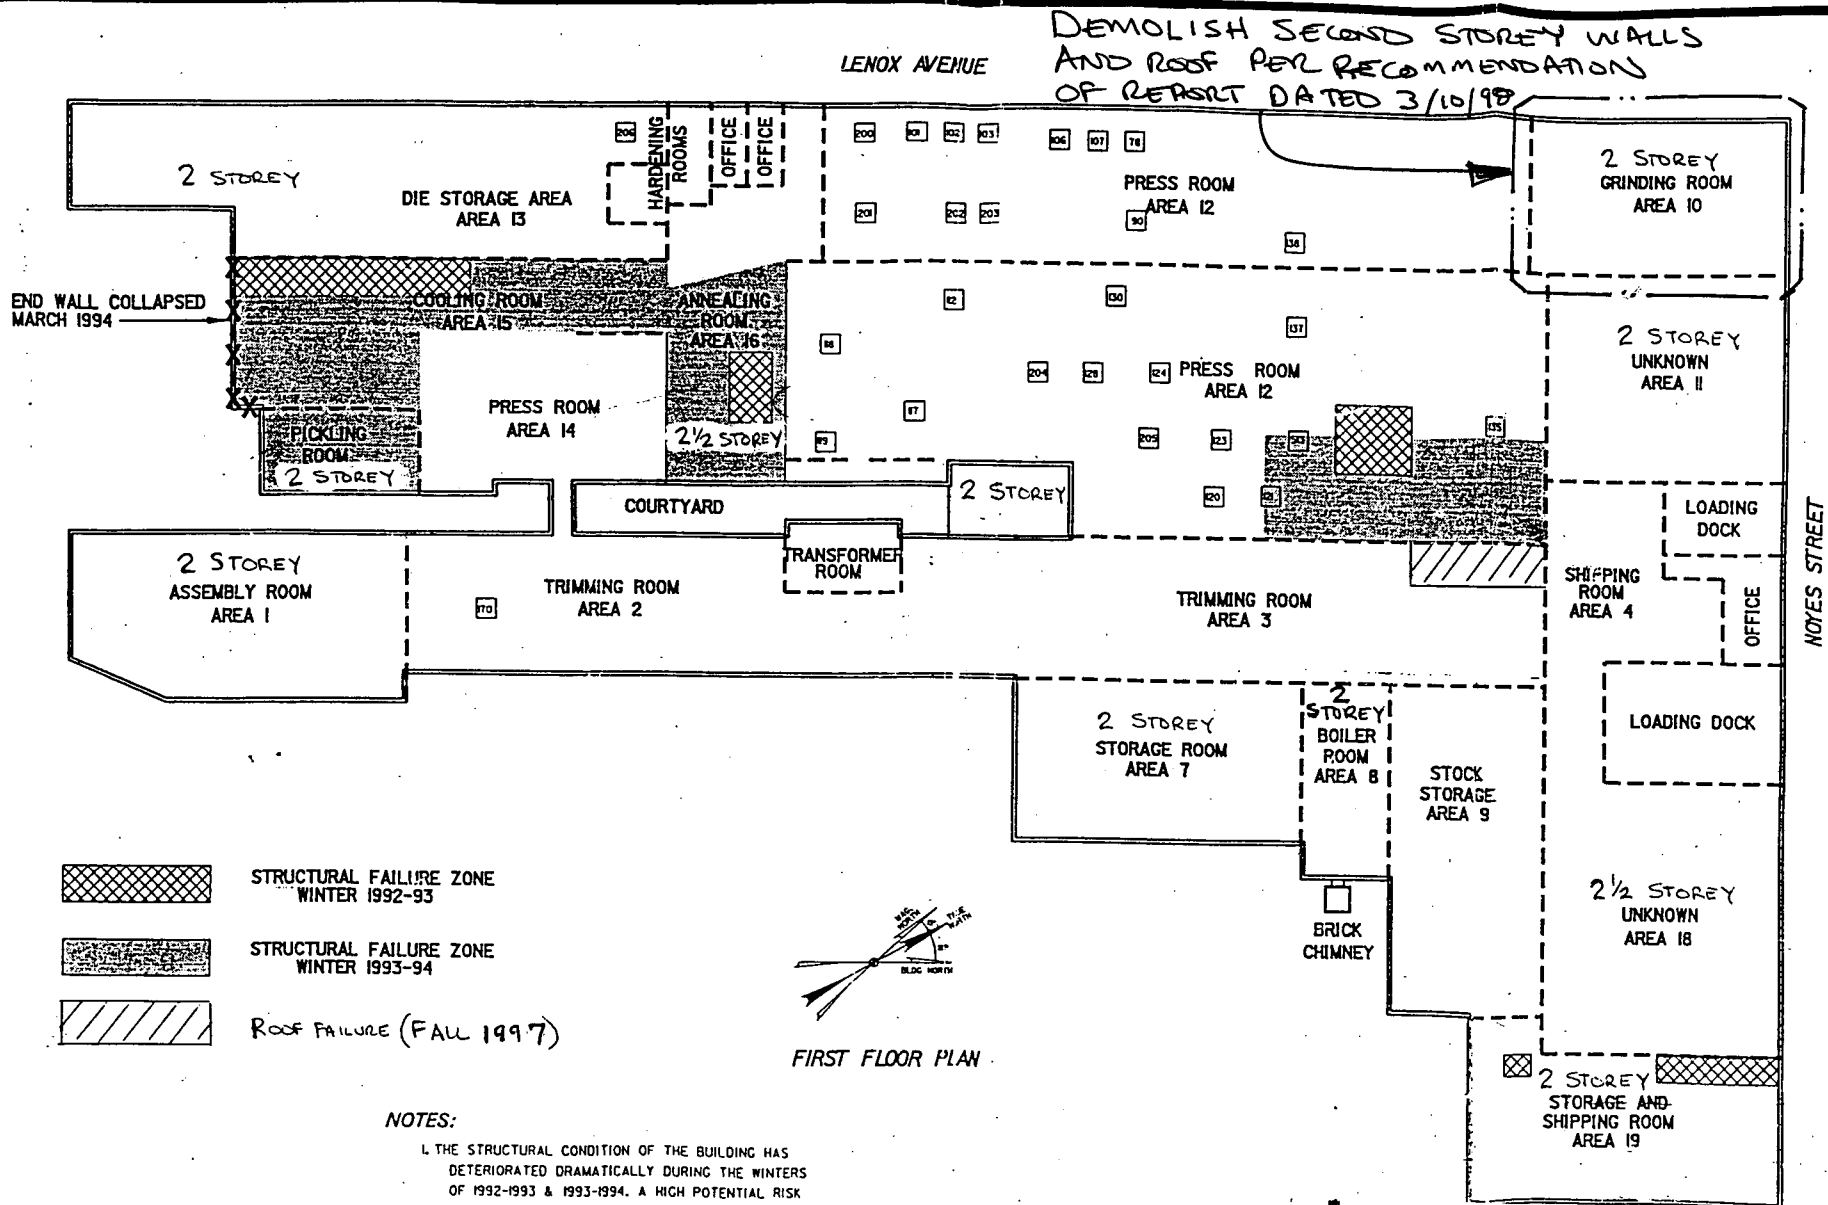
FIG. 4

These observations indicate concern for traffic and pedestrians of Noyes and Lenox Streets. The roof parapet walls are high above the street level and pose the greatest danger of falling debris.\* Refer to Figure 4 of APPENDIX for location.

BOSSERT MANUFACTURING PLANT SITE REMEDIATION  
STRUCTURAL FAILURE ZONES

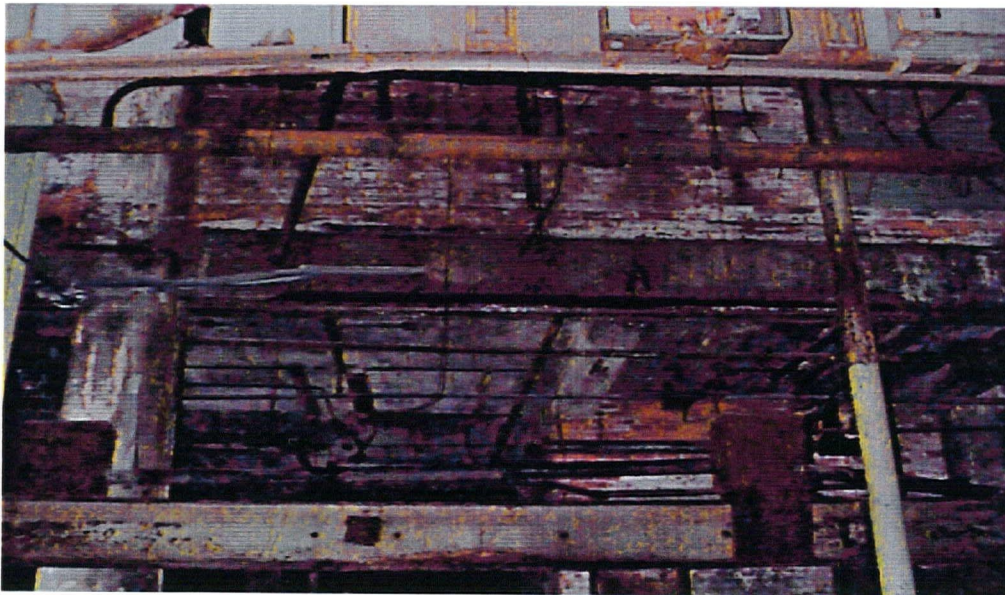
**IMAGE NO. 1**

IMAGE NO.	AREA NO.	DESCRIPTION
1	12	Concrete beam is cracked with exposed rebar. North side of building. No repairs are needed because the beam is considered safe.
2	12	Same as Image No. 1. No repair is required.
3	12	Wood beam has failed near brick wall. East side of building. Repairs should be made per Detail <u>2 &amp; 3</u> of this report.
4	12	Roof Collapse has caused instability of structural frame. See Detail <u>16</u> for repairs.
5	12	Roof failure has cause unstable support columns. Repair per Detail <u>16</u> .
6	12	Loss of beam lintel support at brick wall. Repair per Detail <u>18</u> .
7	12	Roof purlin failure and broken roof sheathing. Repair per Detail <u>13</u> .
8	12	Brick wall has missing or loose brick. Repair per Detail <u>12</u> .
9	12	Severe brick loss at areas of roof support columns. Repair per Detail <u>12</u> .
10	12	Broken wood beam. Repair per Detail <u>2 &amp; 3</u> .
11	10/11	Exterior walls of brick wall are in poor condition. There is to much window area to provide adequate structural support of roof. Demolish second floor walls and roof as described in Report.

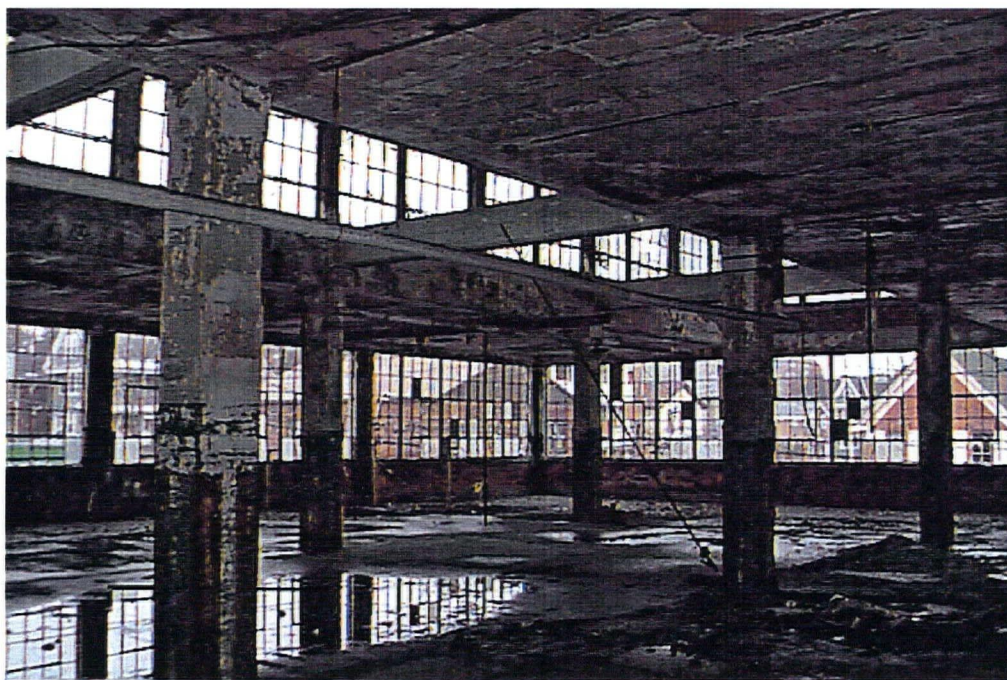
IMAGE NO. 12

12	10/11	Same description as #11.
13	10/11	Same description as #11.
14	10/11	Same description as #11.
15	10/11	Same description as #11.
16	10/11	Same description as #11.
17	10/11	Exterior surface of brick wall. Demolish as described
18	10/11	Exterior surface of brick wall. Demolish as described
19	12	Roof timber beam broken. - Repair per Detail <u>17A</u> .
20	12	Timber beam broken off at wall support - See Plan Item <u>14</u> .

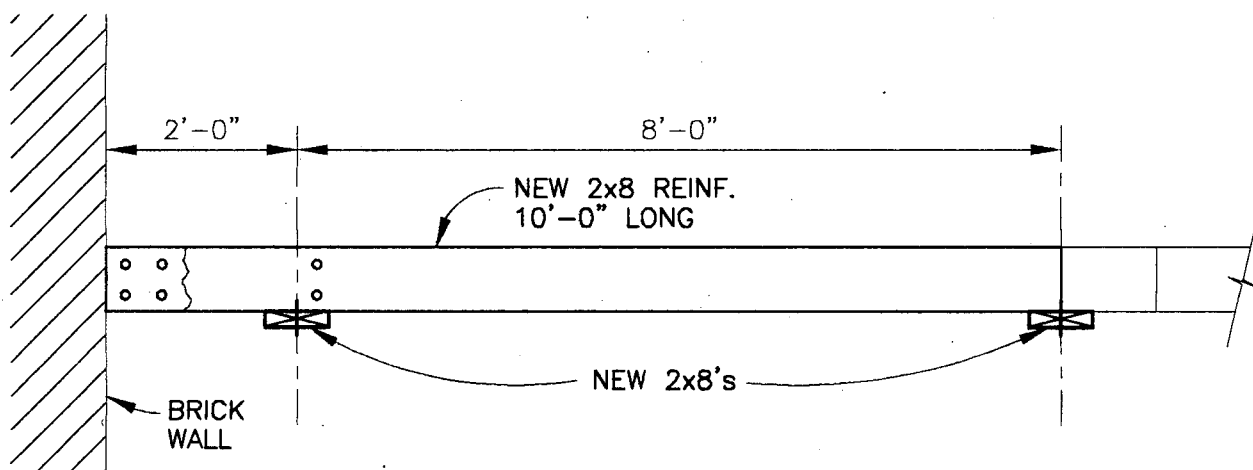
IMAGE NO. 20

| 14 | Timber beam broken off at wall support. | Add jack post to underside of beam 2'-0" from end. See Plan Item <u>14</u> . |

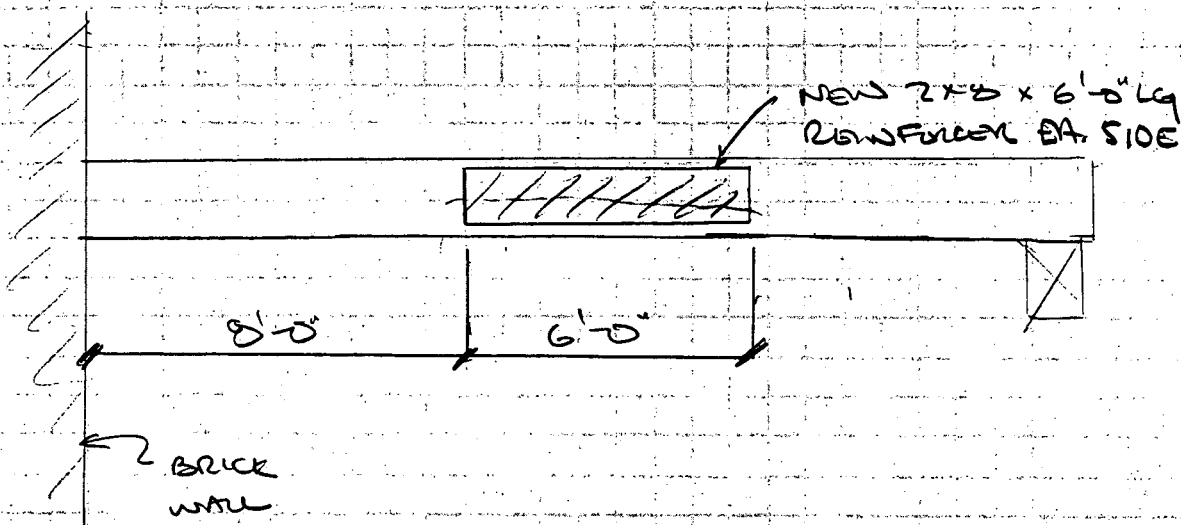
## (3) DETAIL

ITEM NO.	PROBLEM	RECOMMENDED REPAIR
①	Excessive load on timber beams	Remove Fan and support brackets See Plan Detail <u>1</u> .
②	Damaged timber beam	Repair per Detail <u>2</u> .
③	Damaged timber beam	Repair per Detail <u>3</u> .
④	Excessive load on timber beams	Remove (2) Tanks See Plan Detail <u>4</u> .
⑤	Excessive load on timber beams	Remove tank See Plan Detail <u>5</u> .
⑥	Damaged timber beam	Add a 2x8 SMOE between timber beam and rafter. See Detail <u>6</u> .
⑦	Broken timber joist	Repair per Detail <u>7</u> .
⑧	Column is out of plumb and loose at base.	Straighten column and grout under base plate. See Plan Detail <u>8</u> .
⑨	No beam connection Beam end is loose	Weld the existing clip angle to the beam. See Plan-Detail <u>9</u> .
⑩	Short timber beam is not straight	Re-align beam and tie nail to Supporting beam. See Plan-Detail <u>10</u> .
⑪	Missing 2x6 Kicker	Add 2x8 Kicker at (2) locations See Detail <u>11</u>
